**A Feasibility Test of Two NMFS Flounder Turtle Excluder Device (TED) Designs
With Large Opening in the U.S. Mid-Atlantic Scallop Trawl Fishery**

FINAL REPORT

Contract Number: EE-133F-13-SE-2036

Christopher Parkins and Ronald Smolowitz
Coonamesett Farm
277 Hatchville Road
East Falmouth, MA 02536

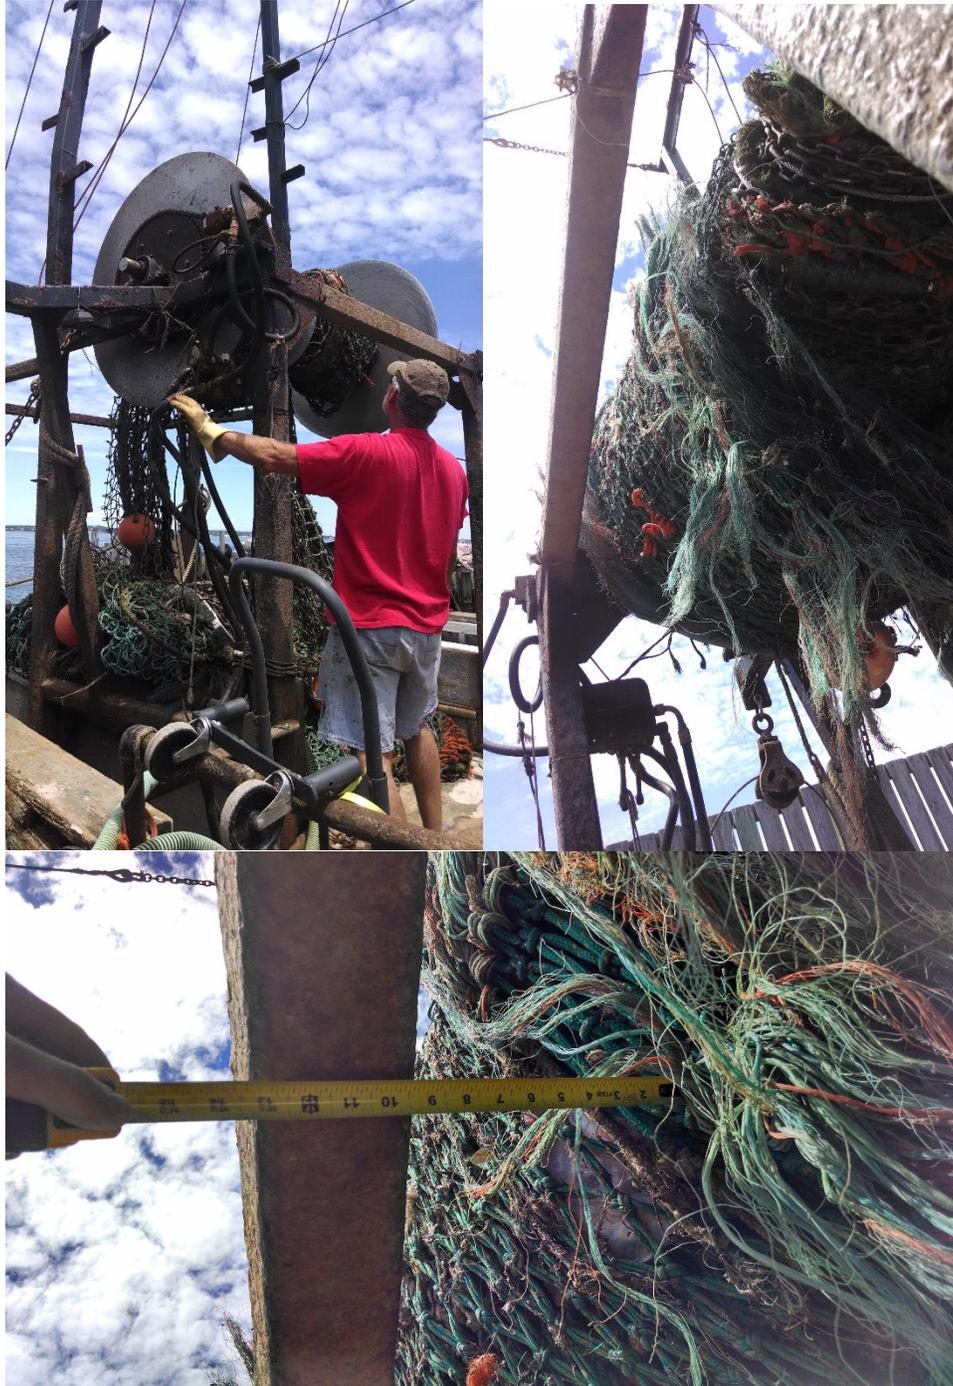
Figure 2. The net reel aboard the FV Elizabeth J showing the horizontal cross bar forward of the reel preventing the installation of the TED

Jeff Kraus, the captain of the FV Elizabeth J, agreed to participate in the project and asked for us to come out with the TEDs for a trip in late June. The captain had concerns about the TED after seeing schematics but indicated that he was willing to try. Upon arrival with the TEDs and looking at the net reel set up it became clear that the TED could not be fished aboard the FV Elizabeth J. The major factor was that the captain could not wind up the net far enough to dump the codend once the TED was installed (Figure 2). The structural support bar located on the forward side of the net reel prevented the TED from being rolled aboard. Though this support bar is not a universal design it has been observed on other small stern trawl vessels, where due to their small size extra support is added to the net drum frame for increased strength. Questionnaire responses are listed in appendix 1. Unfortunately, the lack of participation by this captain meant that we lost participation of another captain in the port who would not participate until he saw the results from the FV Elizabeth J.

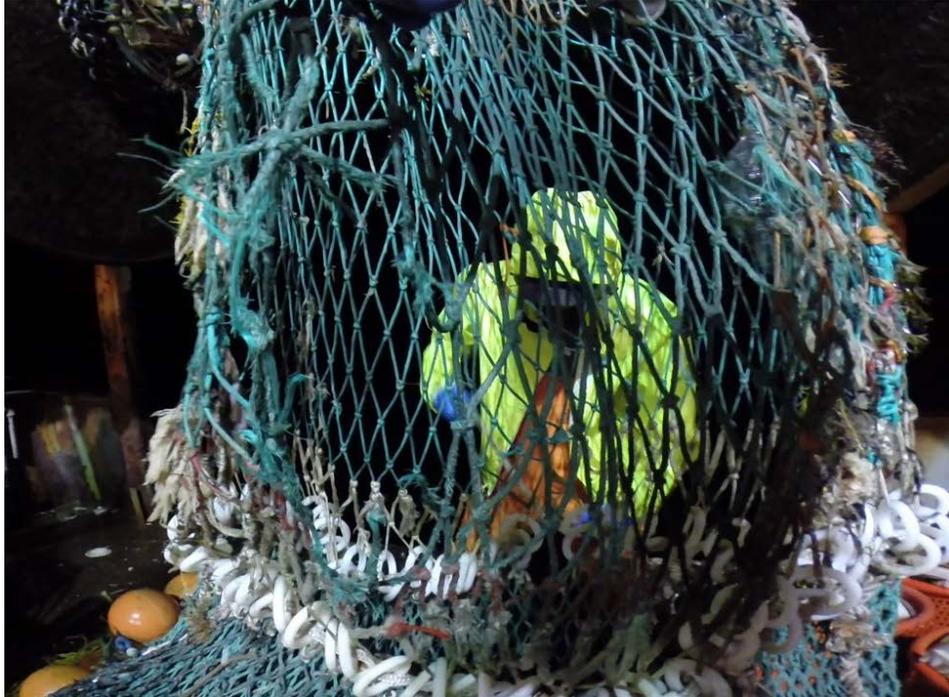
Figure 4. Chaffed lower belly section forward of the TED extension aboard the FV Two Anns

Many problems were consistently encountered while using the TED aboard this vessel. Though the twine chaffing gear in the extension proved sufficient for the limited testing that was performed, it was well worn by the completion of the experimental tows. Over long term use in commercial conditions, a more substantial piece of twine chaffing gear may suffice or may have to be replaced often. Chaffing was observed on the lower belly just forward of the extension indicating a substantial buildup of scallops at the base of the TED (Figure 4). Accumulation of scallops was observed forward of the TED during a majority of tows indicating a persistent problem (Figure 5). This accumulation causes a large amount of scallops, > 3/4 bushel, to sit on top of the TED and come spilling out of the escape opening upon haul back. To get these scallops through the grid, the captain had to manipulate the hydraulics to shake the scallops down through the grid. Twisting of the extension upon haul back was observed during more than half the tows, which required the deckhand to physically turn the net and guide the TED onto the drum so it would not be broken. This is an instance where safety can become a concern in rough weather on a vessel with an open stern. Having the deckhand lean out and guide the net while it is thrashing erratically due to the weight of the TED can put the individual in a compromising situation.

Researcher: Chaffing observed due to clogging on haul 21, see picture. First TED broke on haul 14 and second TED broke on Haul 15. Both TEDs broke during haul back under average loads. First TED did not show signs of fatigue until the last two pair; the second TED broke at the end of the first pair it was installed.

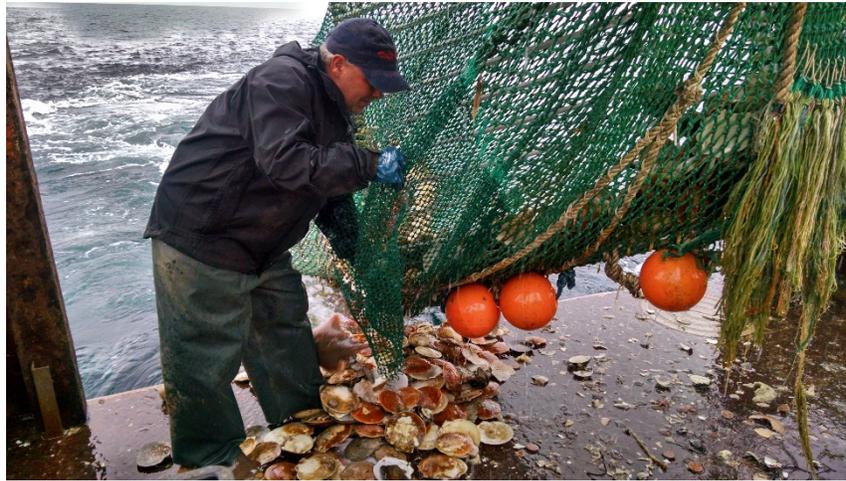
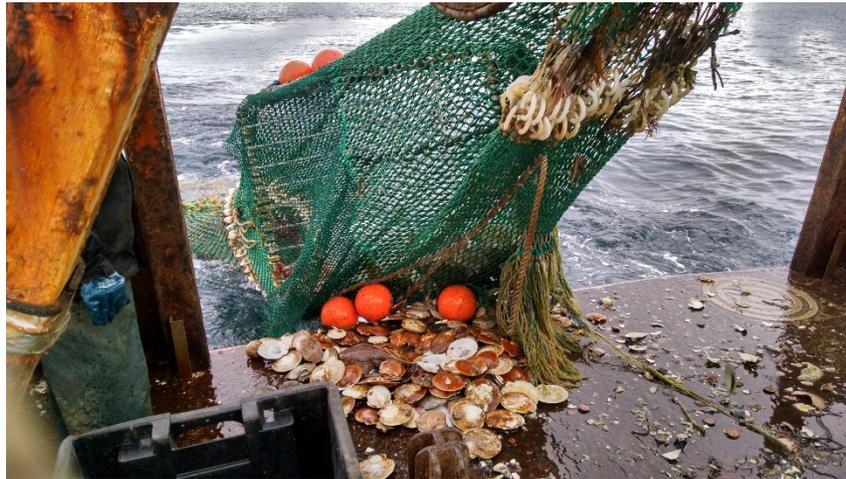
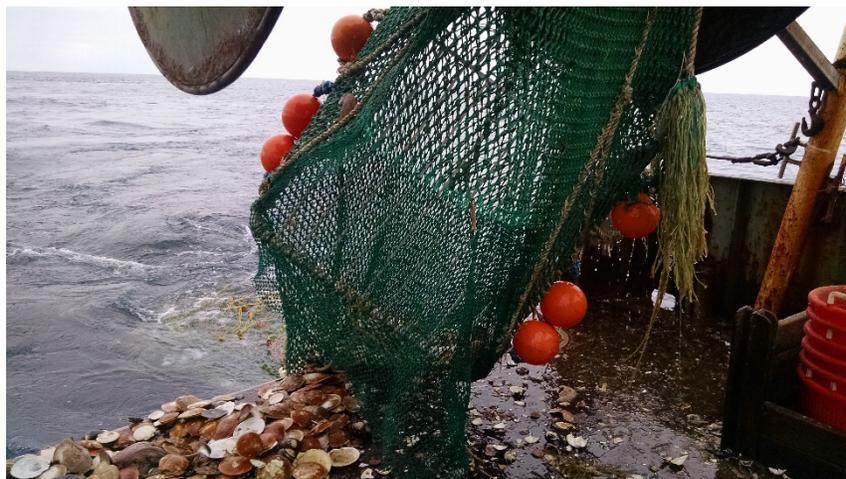
Figure 5. Accumulation of sea scallops in front of the TED upon haul back aboard the FV Two Anns

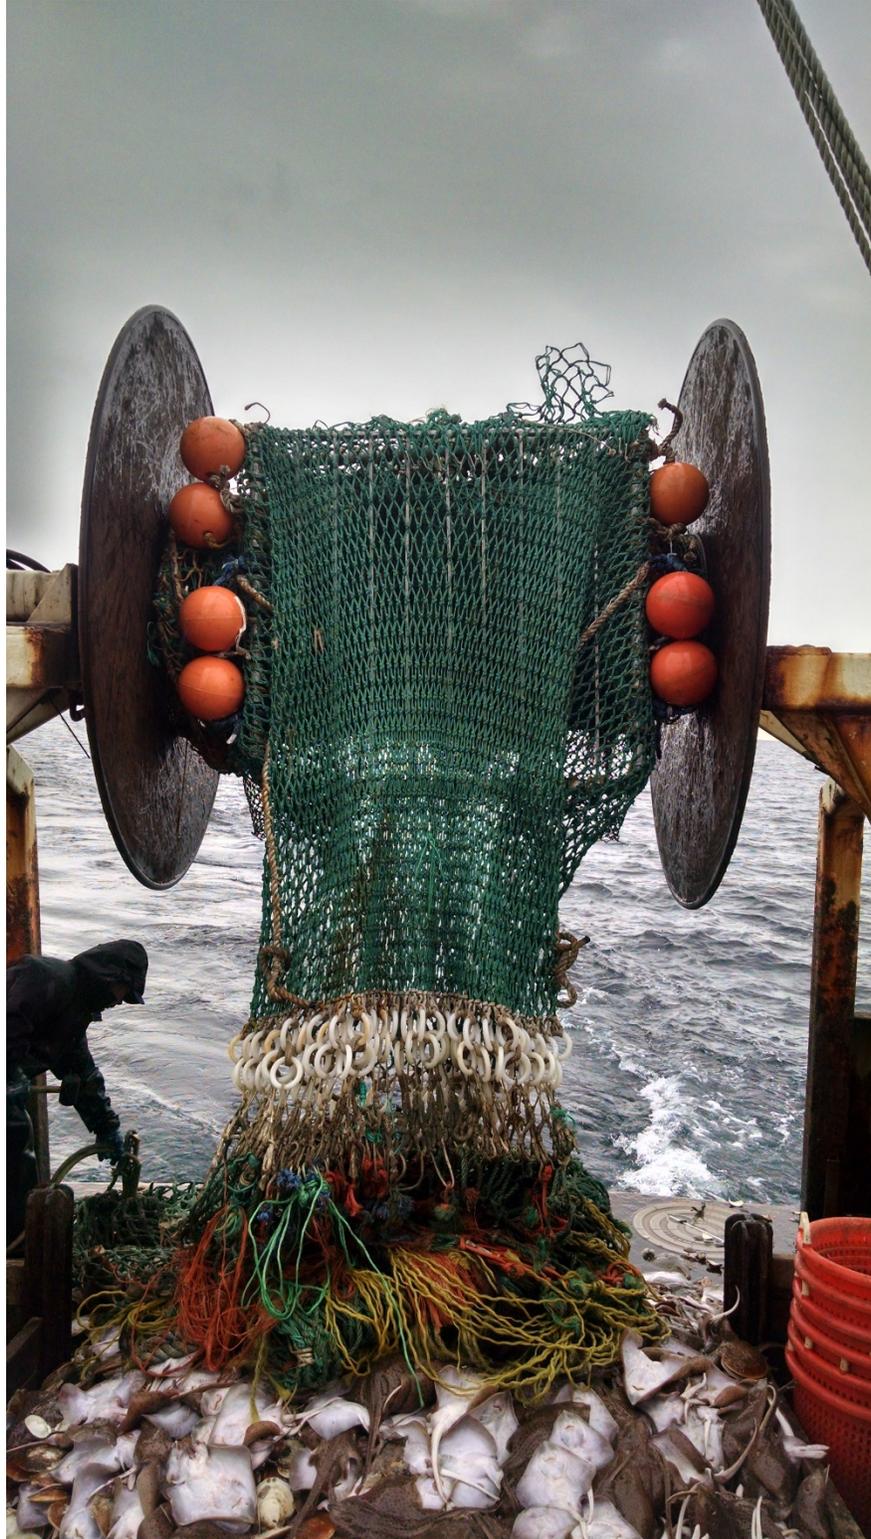
Figure 6. TED on net reel after breaking horizontally above windows aboard the FV Two Anns

The largest problem encountered with the use of the TED was lack of durability. While completing the required 15 pairs (30 tows), the main TED and back up TED were broken. The initial TED lasted 12 pairs (24 tows). During this time, the TED began to show signs of stress on welded joints during the 11th pair. Upon haul back of the 24th tow, the TED broke horizontally along the top of the windows (Figure 6 and 7). The backup TED was installed and broke in the same manner as the first TED after one use. The second TED had been used in previous research and may have been weakened, though both TEDs were inspected and no signs of stress or fatigue were observed. Both TEDs were built by the same manufacturer, but due to where they broke appeared to be a weak point in the design when rolled on a net reel. The TEDs were rendered unusable after they broke and the last two pairs could not be completed.

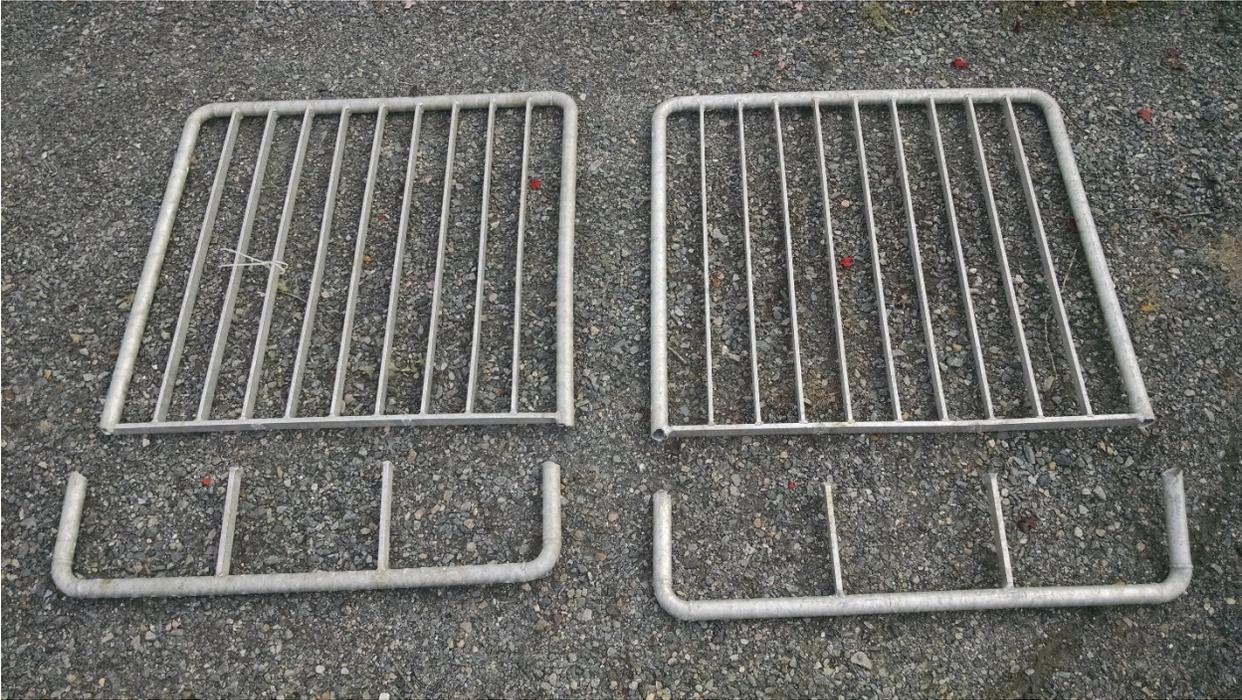
Figure 7. Both broken TEDs removed from the extension pieces

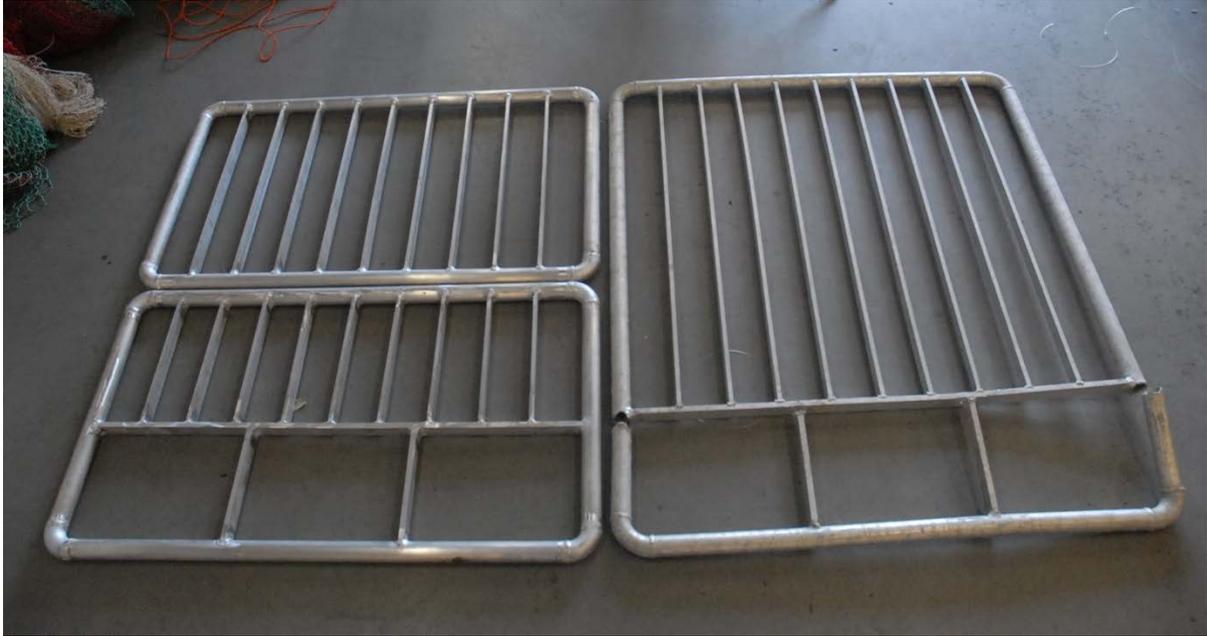
Figure 12. Image showing the bifurcated NMFS flounder TED tested in 2015, next to the original NMFS flounder TED tested in 2014

The grid tested was a bifurcated NMFS-approved flat bar flounder TED, rectangular in shape and hinged in the center, measuring 46 x 54 inches overall (Figure 11 and 12). The TED was constructed of round aluminum pipe around the perimeter, with vertically-oriented flat aluminum bar spaced 4 inches apart. The hinge was constructed using two horizontal sections of round bar that were laced together using twine. The lower section of the TED was designed to have three windows or openings in the lower section that measure 14.1 x 10.0 inches. The TED was installed, at a 48° angle, in an extension constructed of double twine, braided polyethylene netting, 27 meshes in depth and 100 meshes around. The mesh size throughout the extension was 3.5 inches to meet the requirements for proper TED installation. The escape opening in the extension forward and above the TED was 41 x 28 inches (21x8 meshes), rectangular in shape and designed to meet the large opening requirement (50 CFR 2.223 (2012)). A small mesh single flap cover of 1.5 in mesh was used to close the escape opening. Chaffing gear used included extra webbing as well as standard unbraided twine mat.

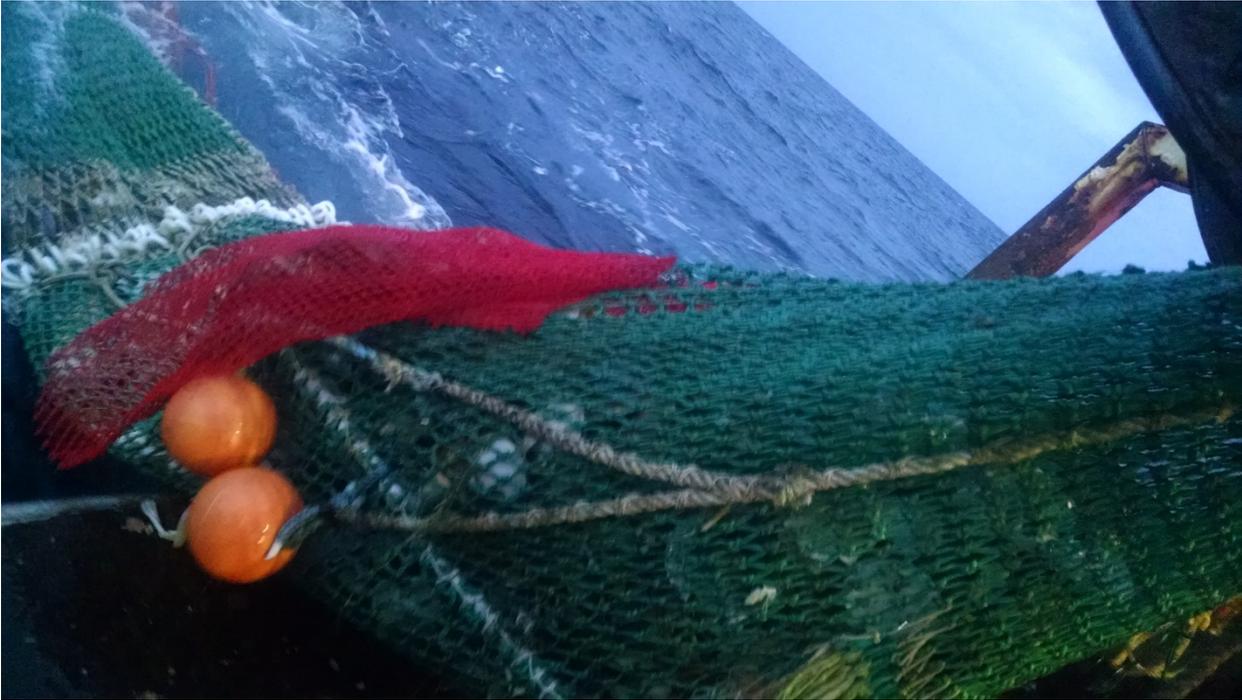
Figure 13. Image showing the level of clogging observed aboard the FV Two Anns

Many problems occurred while towing the bifurcated NMFS certified flounder TED off the stern rigged trawler. Clogging forward of the TED was observed during all of the haul backs, and catch was observed spilling out of the escape opening (Figure 13). The clogging was compounded by the fact that the TED would roll upon leaving the water during 75% of the tows and dump much of the buildup out of the escape opening. This may have been due to the prop wash of the vessel or a heavy cross tide that caused catch to buildup on one side of the net. To mitigate this the captain would quickly haul the TED onto the net drum increasing the chances the TED would wind on incorrectly and be broken if used in day to day operations. When wound on correctly the TED sat correctly on the drum and did not show any signs of structural failure when under load.
